SR 308 MP 2.16 Unnamed Tributary to Liberty Bay (991000): Preliminary Hydraulic Design Report

The proposed project will replace the existing 114-foot-long, 30-inch-diameter concrete culvert with a structure designed to accommodate a minimum hydraulic width of 20 feet. The proposed structure is designed to meet the requirements of the federal injunction using the confined bridge design criteria as described in the 2013 WDFW Water Crossing Design Guidelines (WCDG) (Barnard et al. 2013). This design also meets the requirements of the WSDOT Hydraulics Manual (WSDOT 2022a).

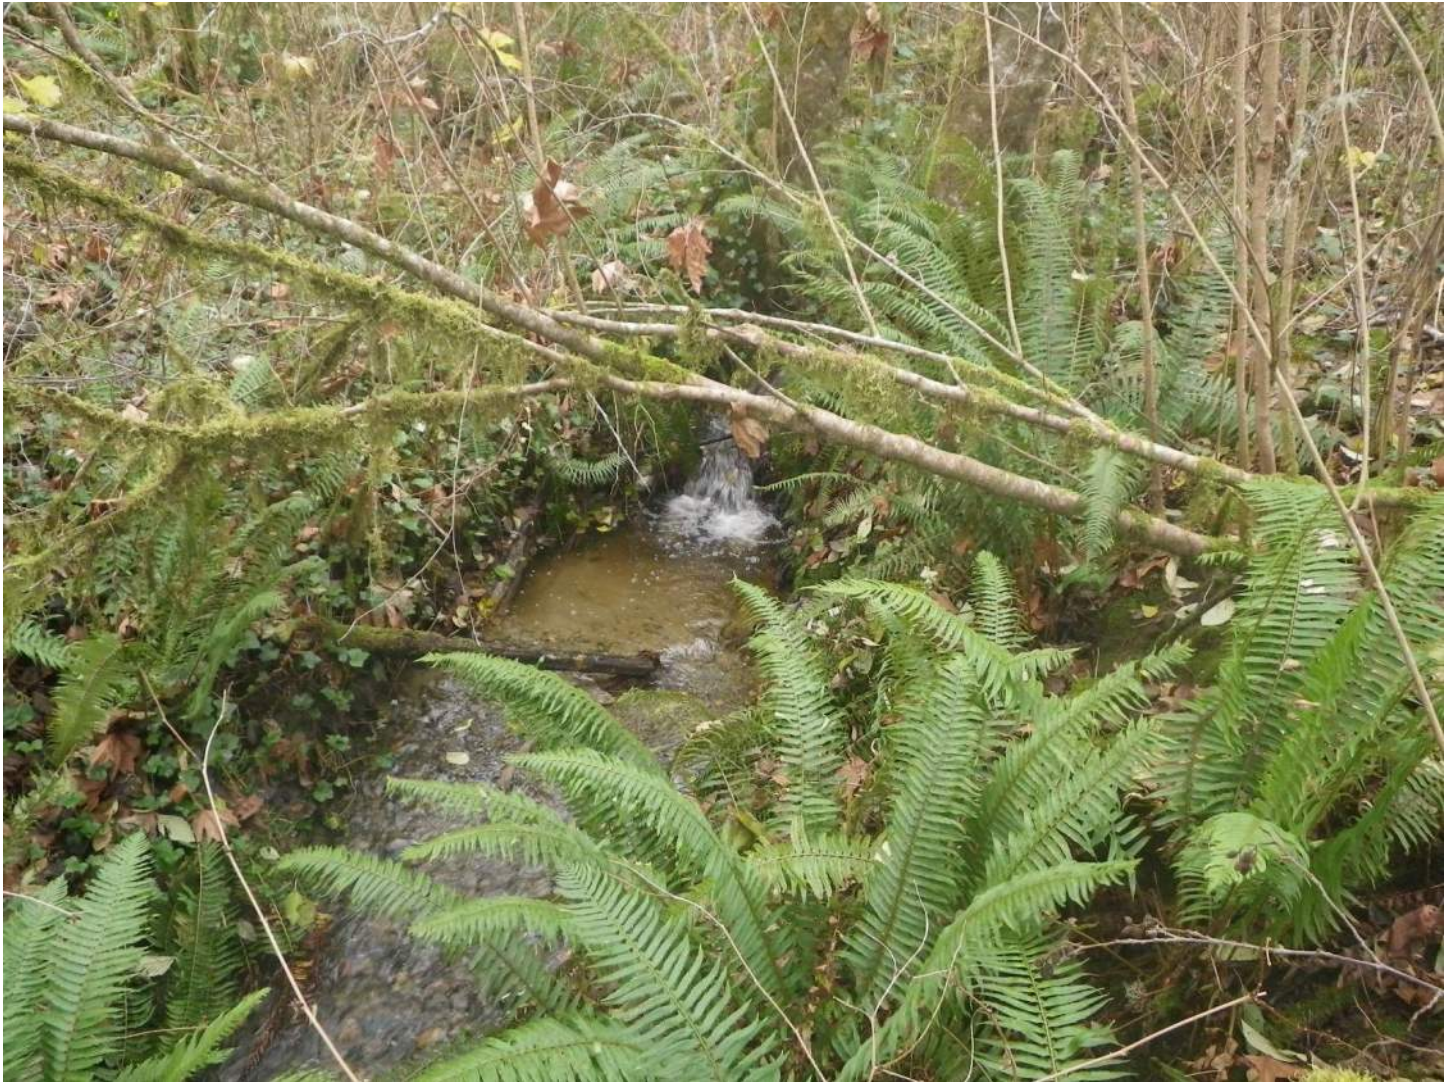
Figure 7. Plunge Pool Caused by Woody Debris and Riparian Vegetation

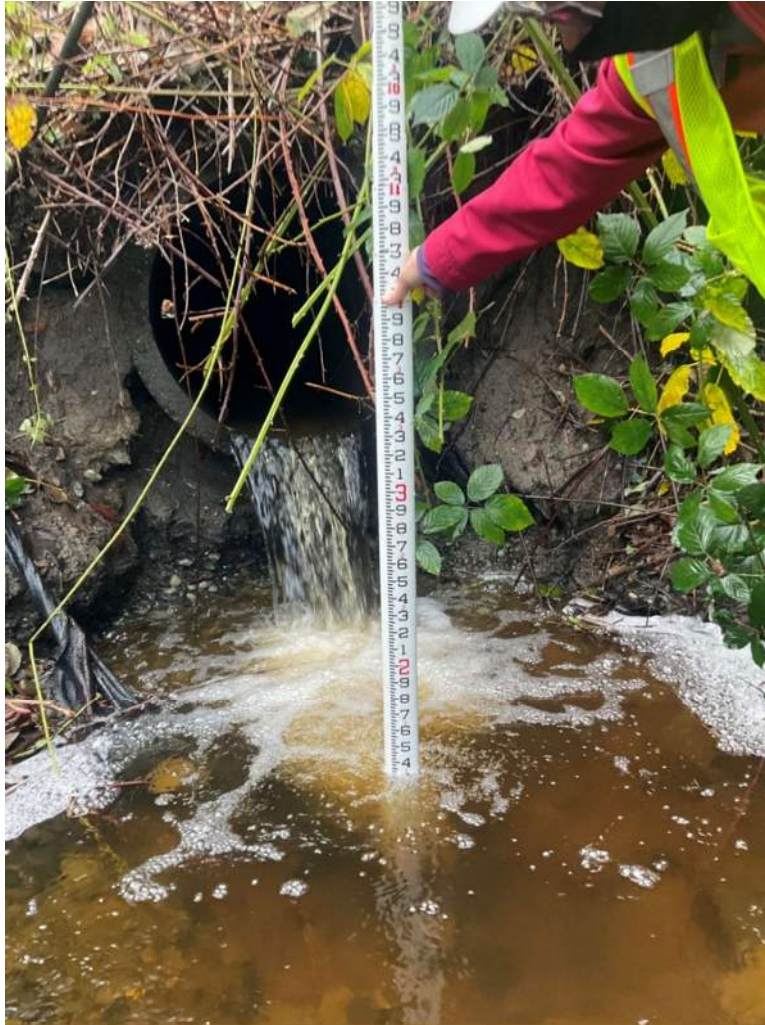
Figure 8. Flow at the downstream end of the culvert.

Data was collected by staff engineers from David Evans and Associates, Inc. on November 29th, 2021. The field crew included the lead author for the PHD at this site, both junior engineers and senior engineers with experience in data collection for Fish Passage projects, and a Geomorphologist. The downstream end of the site was visited first. Observations were recorded, including a pebble count and bankfull width measurement. Next, the upstream side of the culvert was visited. It became apparent that the upstream channel was a more appropriate reference reach. Three bankfull width measurements and a pebble count were collected within the reference reach. The site was visited again on December 1st, 2021 with two Biologists from DEA, who made observations regarding the habitat benefits of the site. Flow in the channel during these site visits was on the order of 1 cubic foot per second or less. See Figure 8.

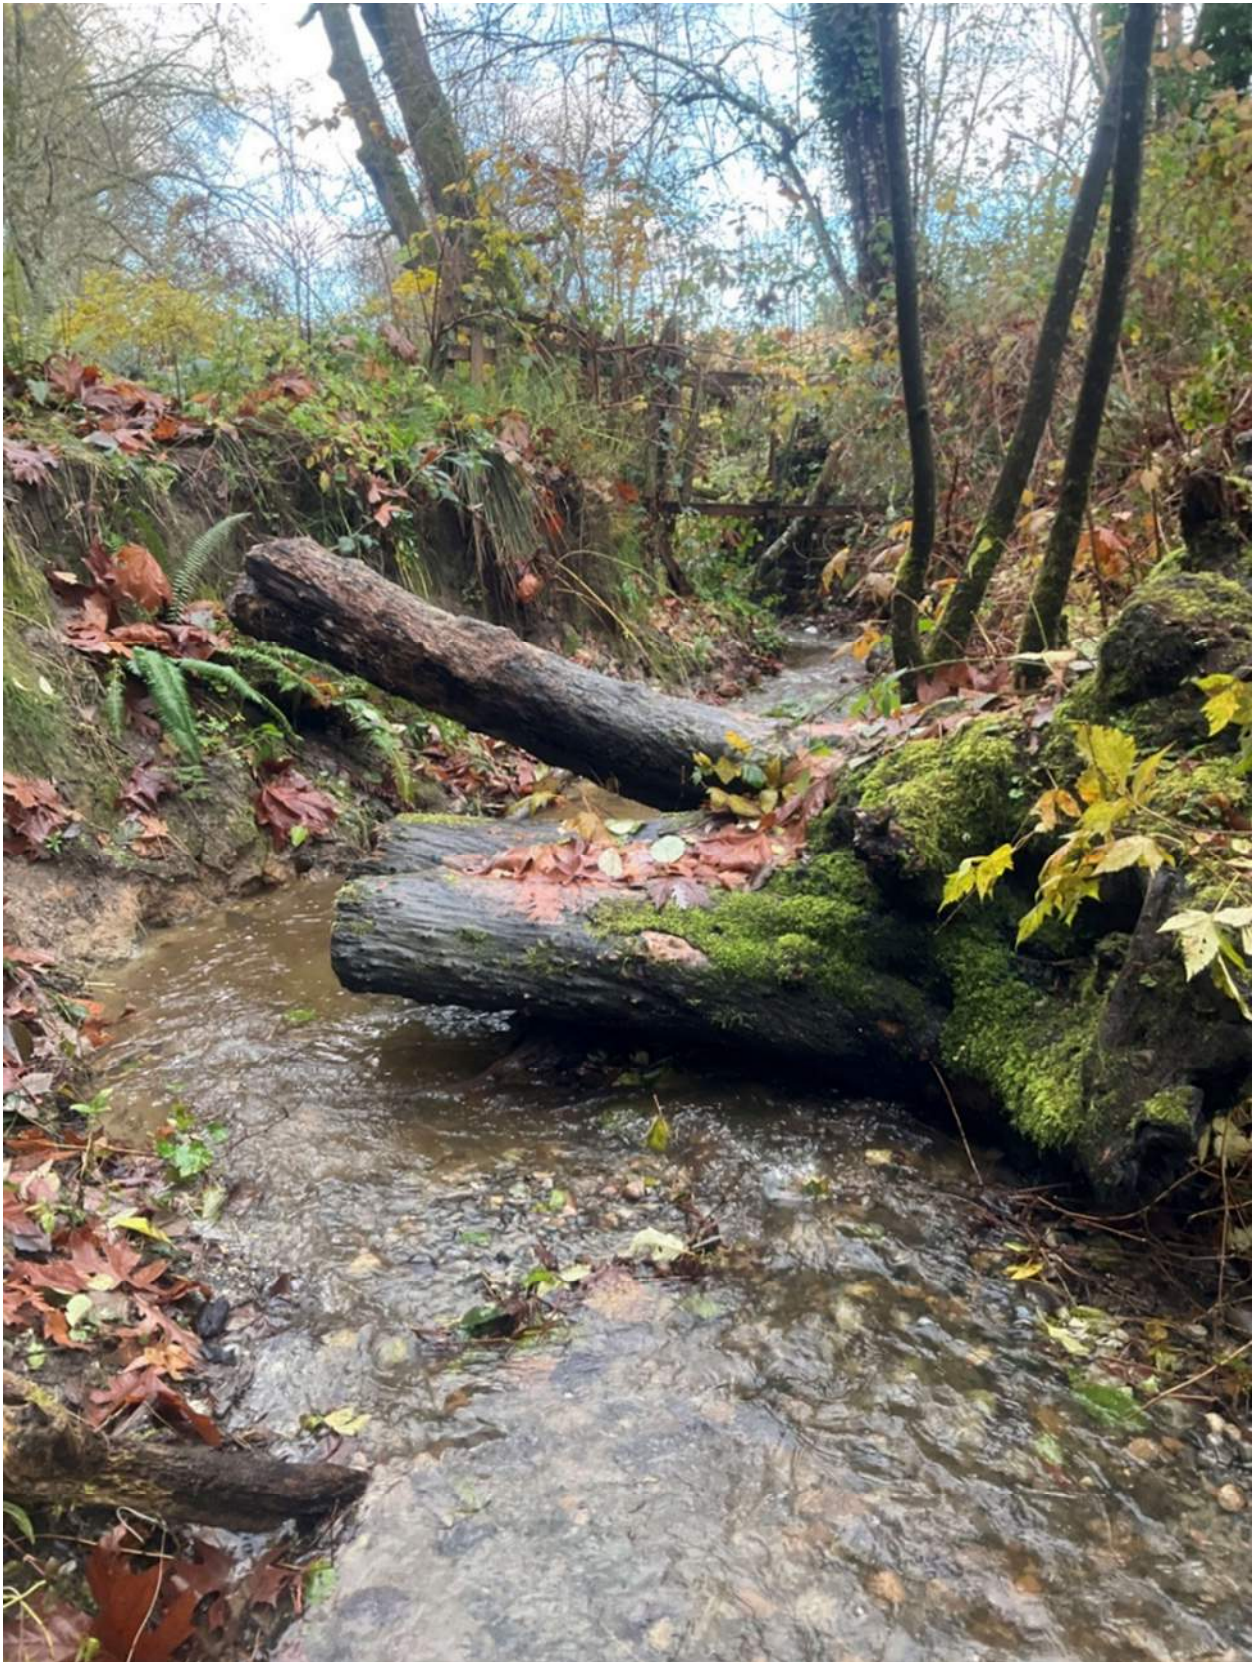
Figure 9. Channel Widening and Bank Incision due to Stump

Figure 9). The incision in this section is likely due to channel adjustment as a response to straightening and over-steepening. Downstream of this incised section the channel is no longer straight and incised, and the bed consists of a combination of both coarse and fine materials. The channel widens due to reduced channel slope, reduced bank vegetation, and potential human and animal use (Figure 10).

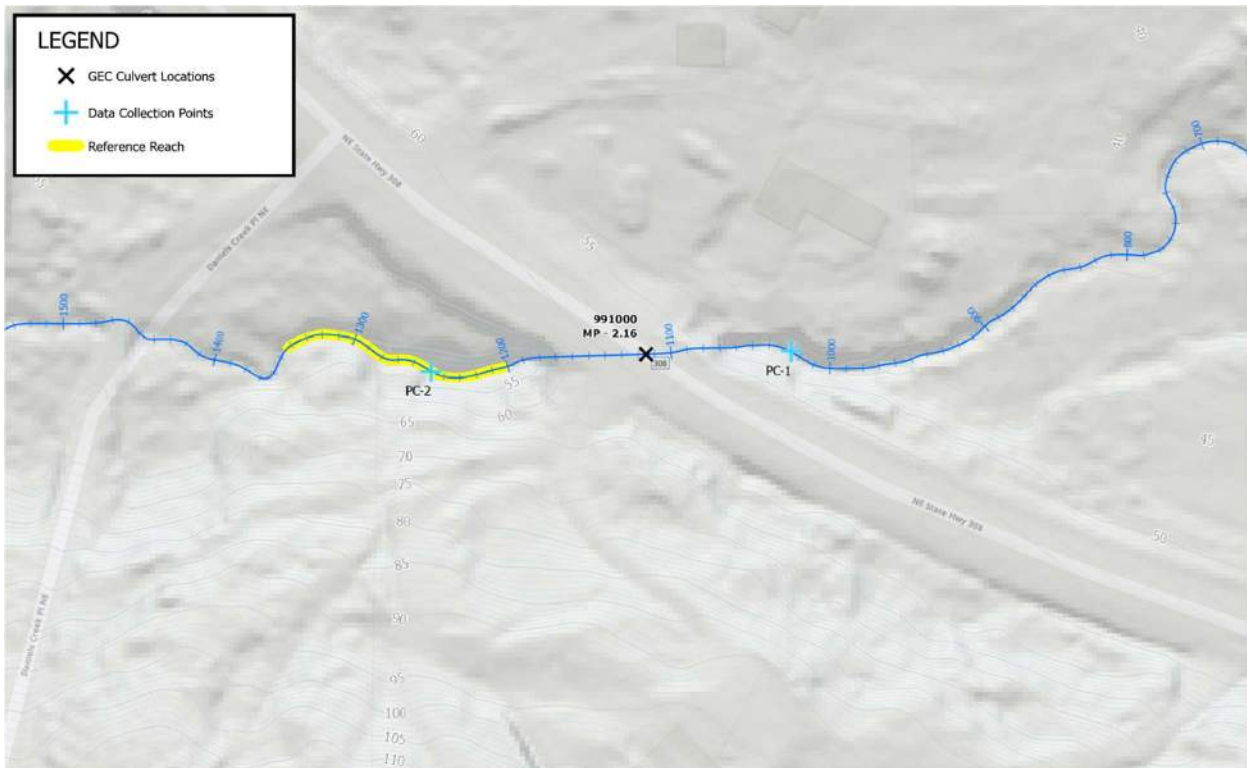
Figure 11. Pebble Count Locations

Two Wolman Pebble Counts (PC) were conducted at this site. See Figure 11 for pebble count locations.

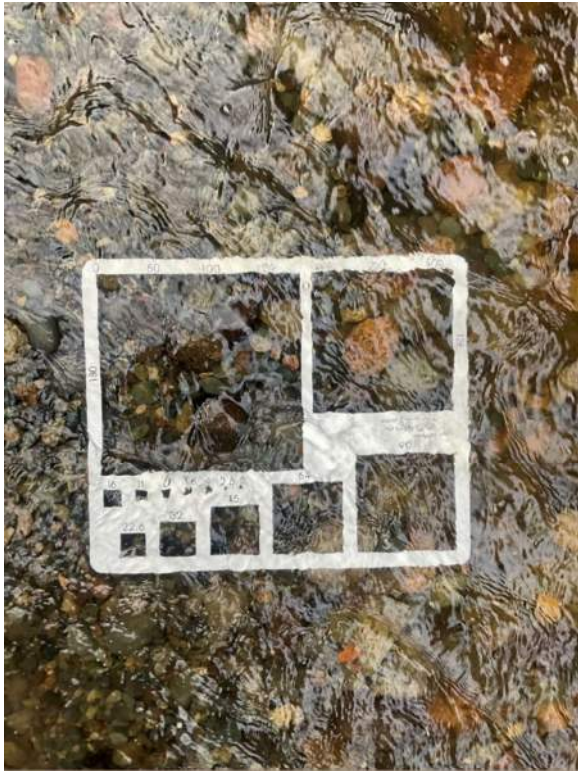
Figure 12. PC-1 Sediment w/ Gravelometer

PC-1 was conducted along a length of stream approximately 30-50 downstream of the existing culvert outlet. The sediment here consisted of coarse sands, gravels, and small cobbles 90 millimeters or less. The sediment at this location was coarsened in comparison to the reference reach due to increased velocities in this reach, evidenced by the scour and erosion mentioned in the reference reach section above. See Figure 12 and Figure 13.

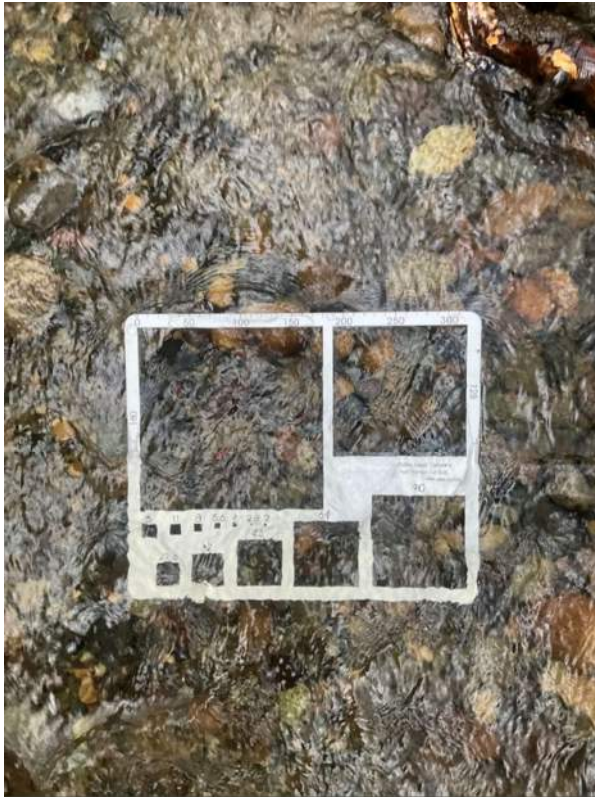
Figure 14. PC-2 Sediment w/ Gravelometer

PC-2 was conducted along a length of stream approximately 55-65 feet upstream of the existing culvert inlet. The sediment here consisted of coarse sands, gravels, and small cobbles 64 millimeters or less. See Figure 14 and Figure 15. The pebble count location within the reference reach was taken at a location that exhibited a gravel and cobble plane-bed morphology with few fines because of the more rapid and shallow flow characteristics. Therefore, this pebble count represents the upper size limit of coarse material that could be mobilized by the stream without the influence of wood material or other potential grade controls. In pools this material will become overlaid with sand as was observed within the reference reach.

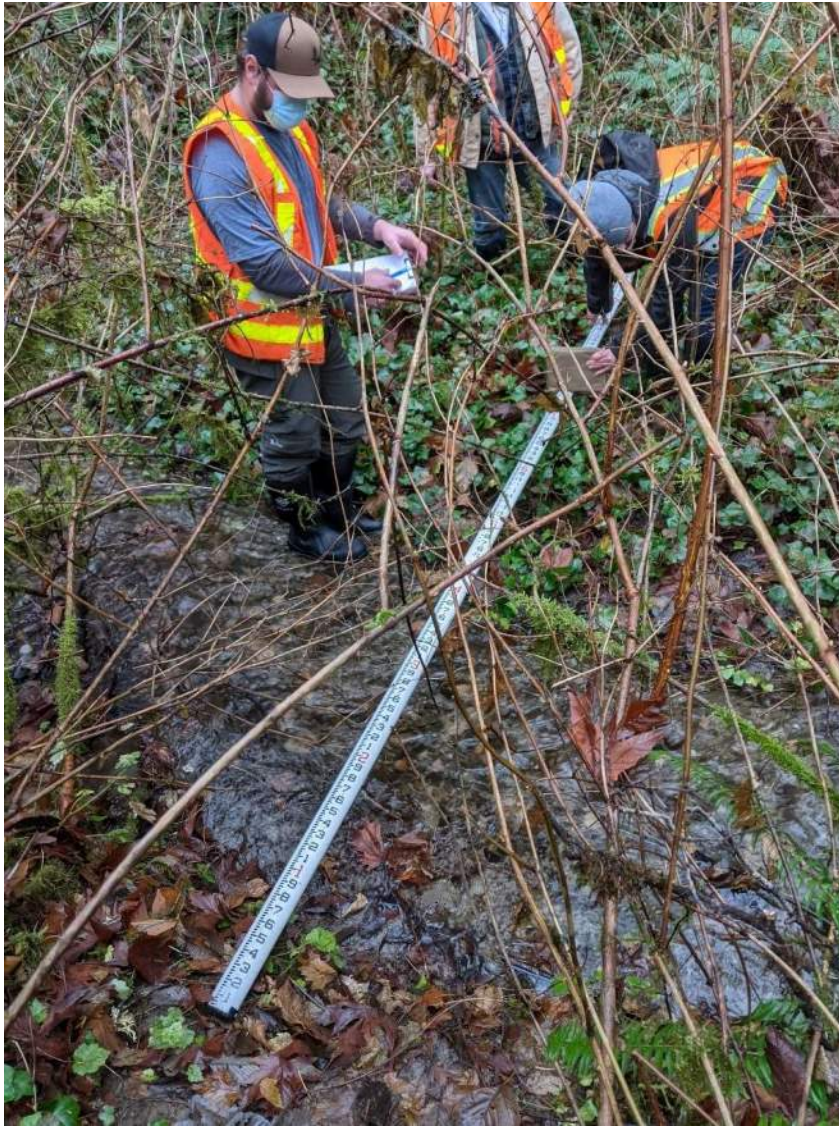
Figure 17. Approximate BFW-6 Measurement Location

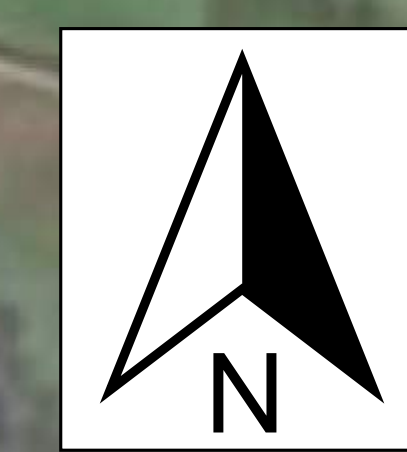
Figure H.1: Existing conditions 2-year depth

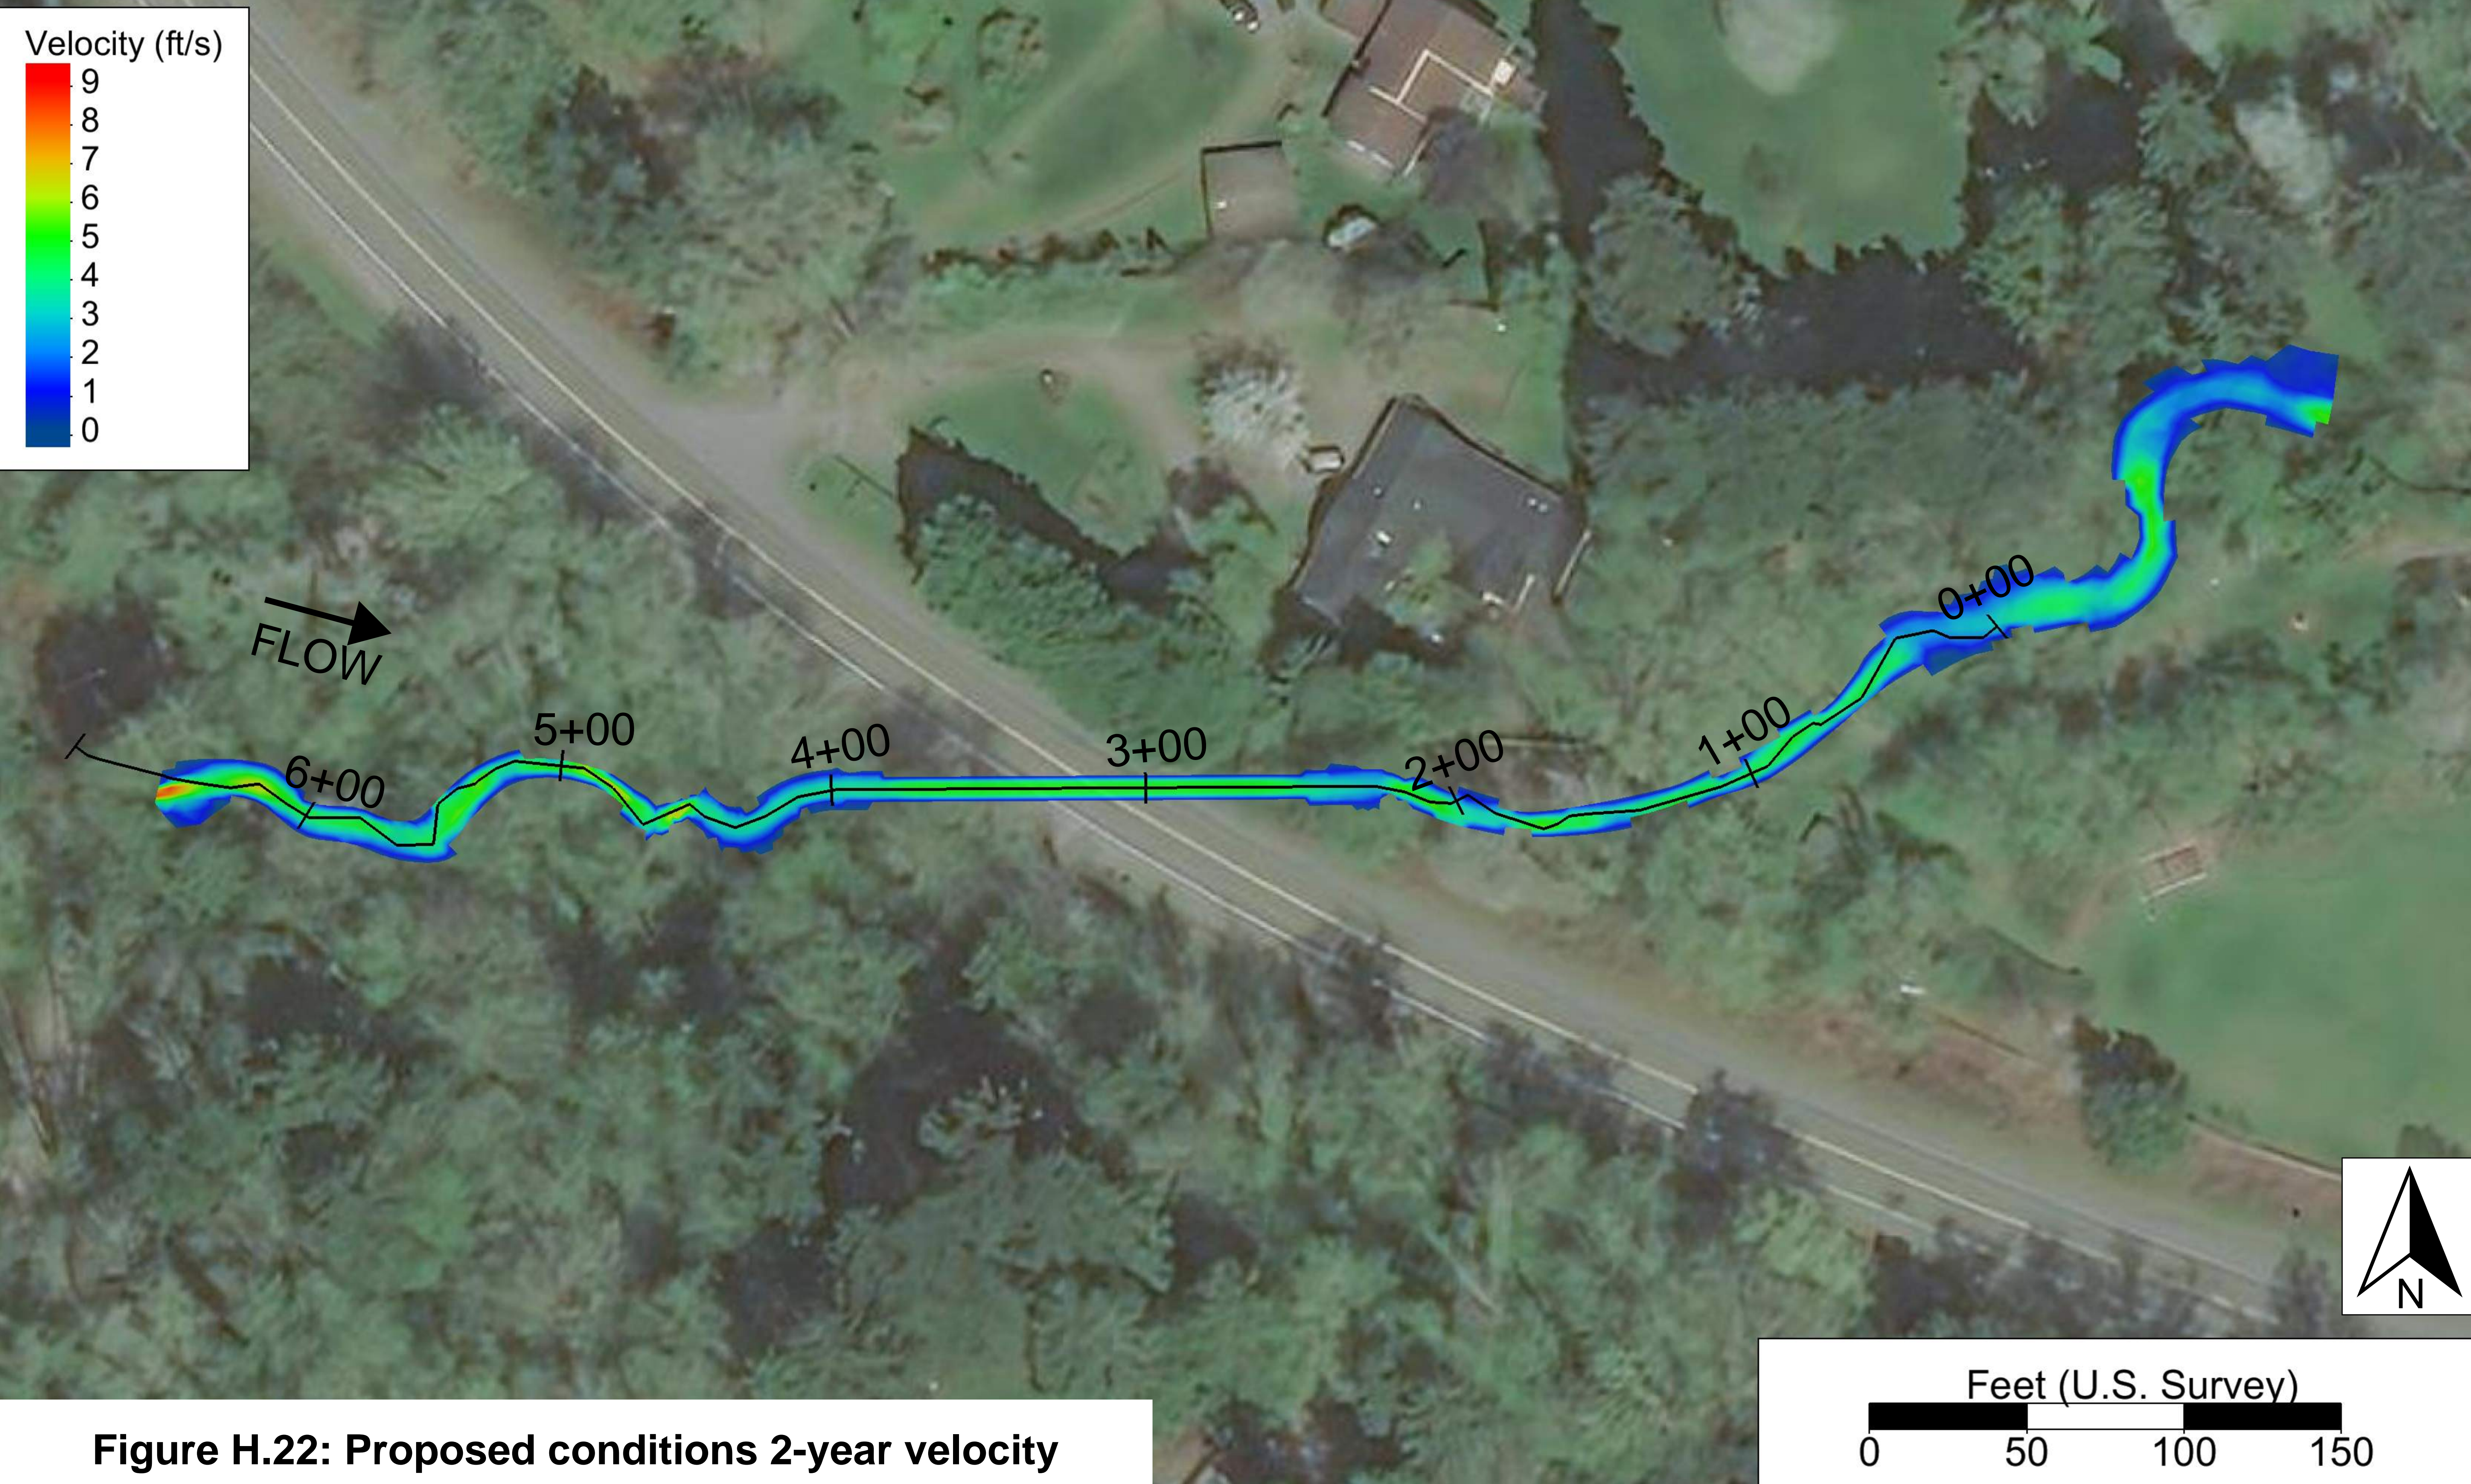
Figure H.22: Proposed conditions 2-year velocity

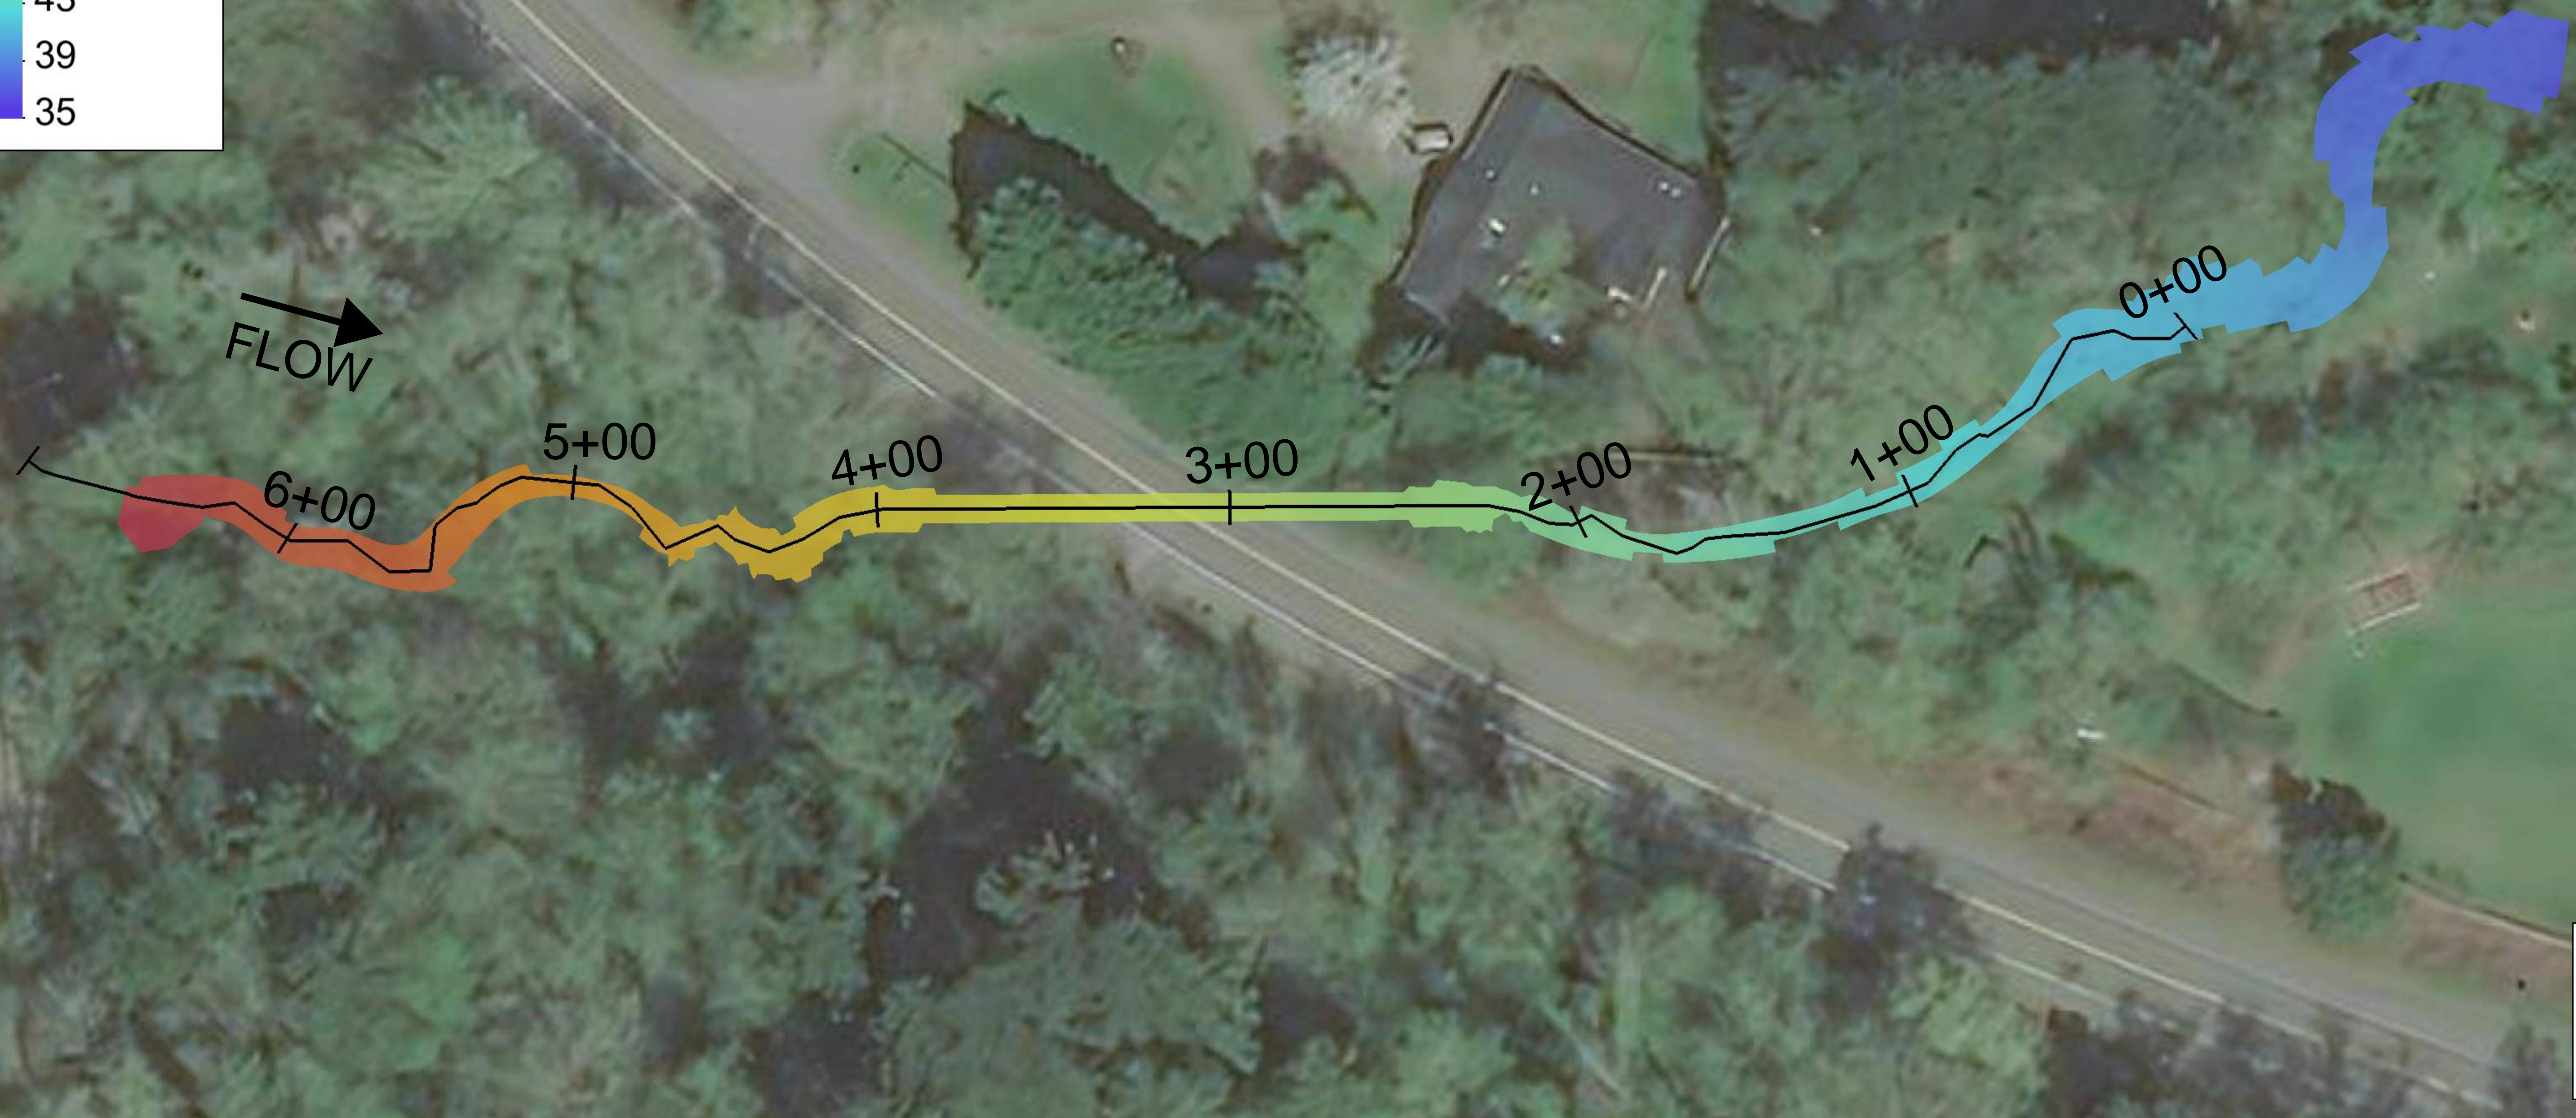
Figure H.23: Proposed conditions 2-year WSE

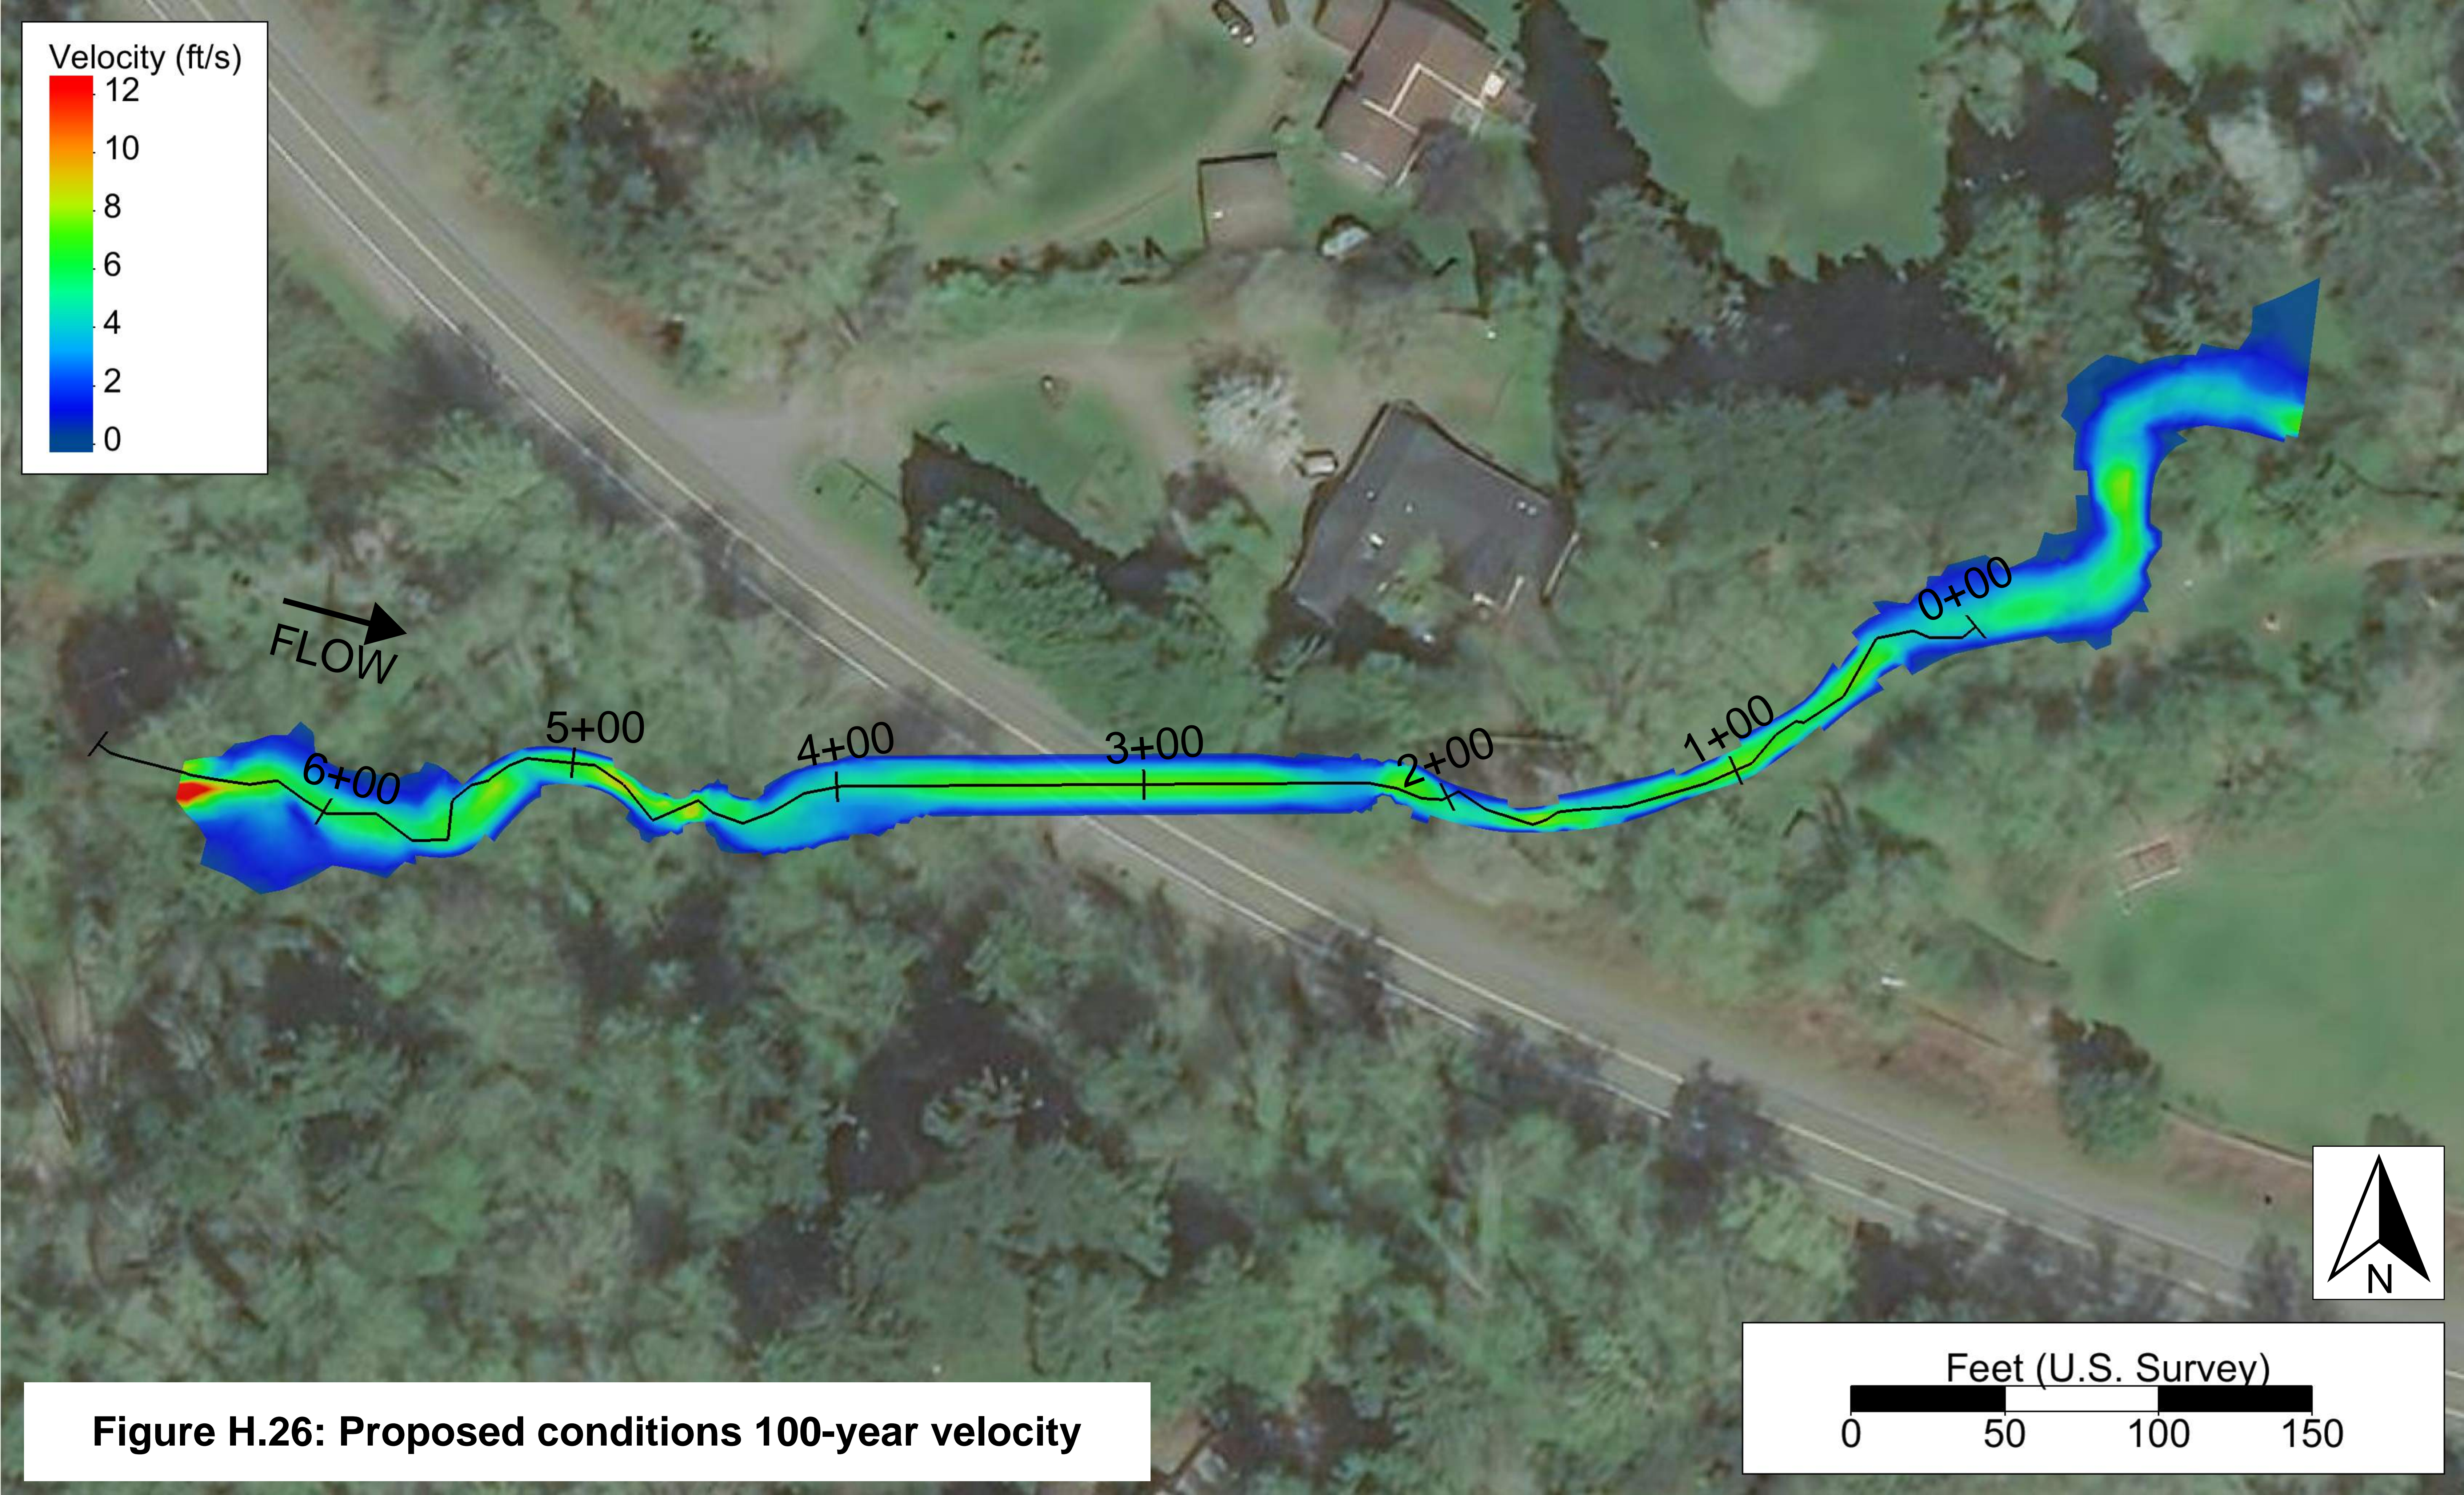
Figure H.26: Proposed conditions 100-year velocity

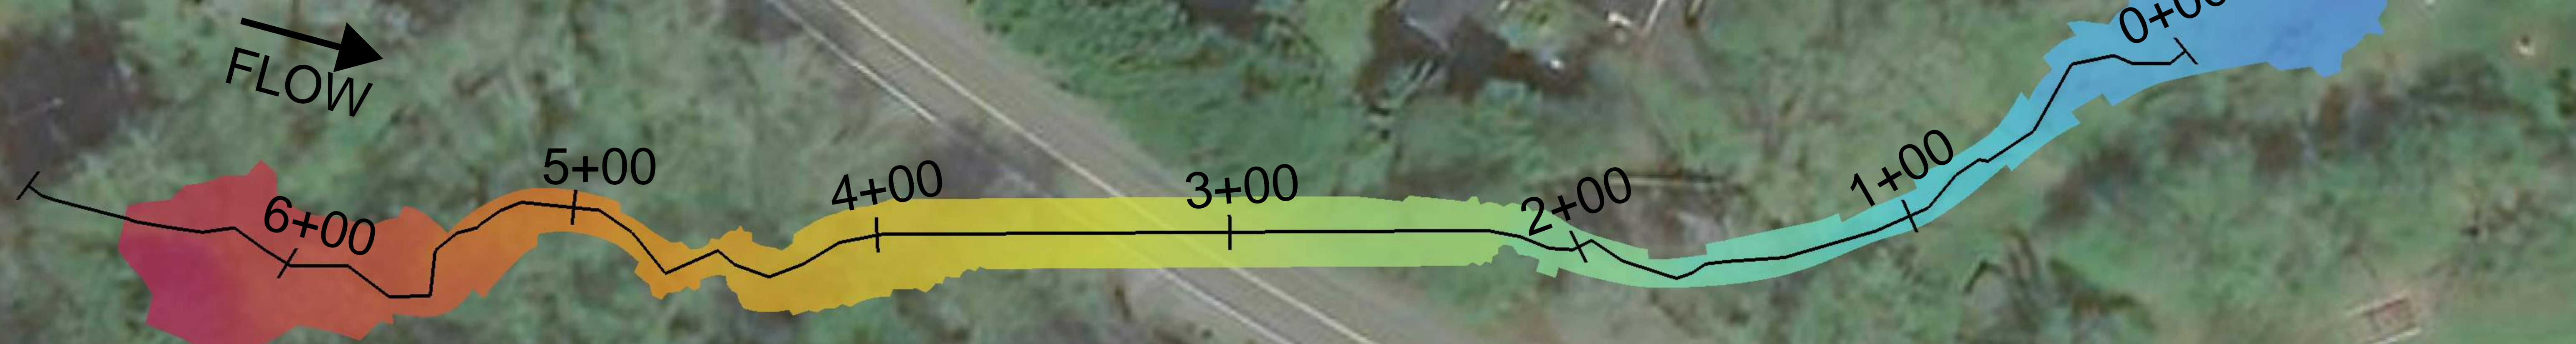
Figure H.27: Proposed conditions 100-year WSE
